# EVALUATION OF TOWN-OWNED PROPERTIES TOWN OF MARBLETOWN, NY

PREPARED FOR:  
Town of Marbletown  
1925 Lucas Ave.  
Cottkill, NY 12419

Peak Engineering, PLLC  
3751 Main Street – PO Box 540  
Stone Ridge, NY 12484

July 9, 2019

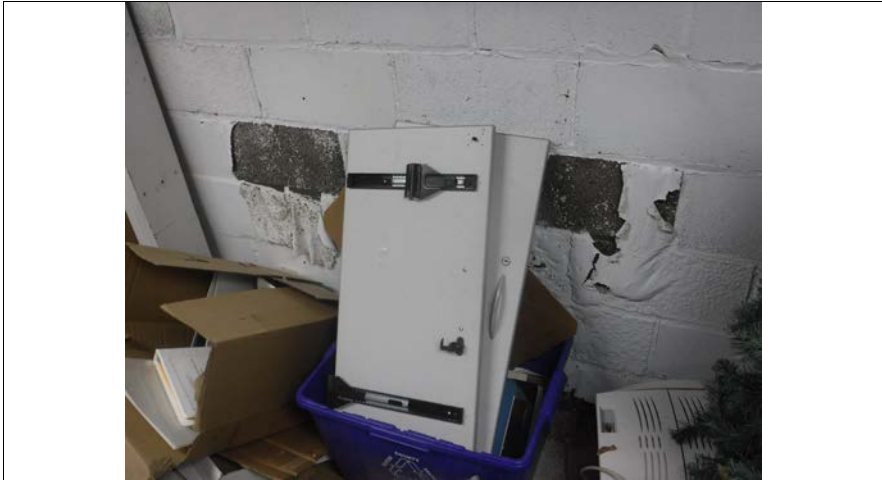
Photo 9

The basement walls are concrete masonry, and the basement floor is slab on grade. The basement has been retrofitted with both wood and steel columns installed tight to the walls. These columns are anchored to the floor system above and concrete slab below, consistent with a strategy to brace the walls against soil pressure (Photos 7, 8). Moisture in the basement walls was observed, as was standing water on the slab floor along the basement perimeter walls (Photos 10, 11, 12). The paint on the basement walls is bubbling in places and peeling off in others, which is consistent with excessive moisture entering the basement (Photo 9).

1. Re-lay settled flagstone near staircase.
2. Apply waterproofing compound to basement wall to reduce water intrusion.
3. Repoint brick masonry veneer.

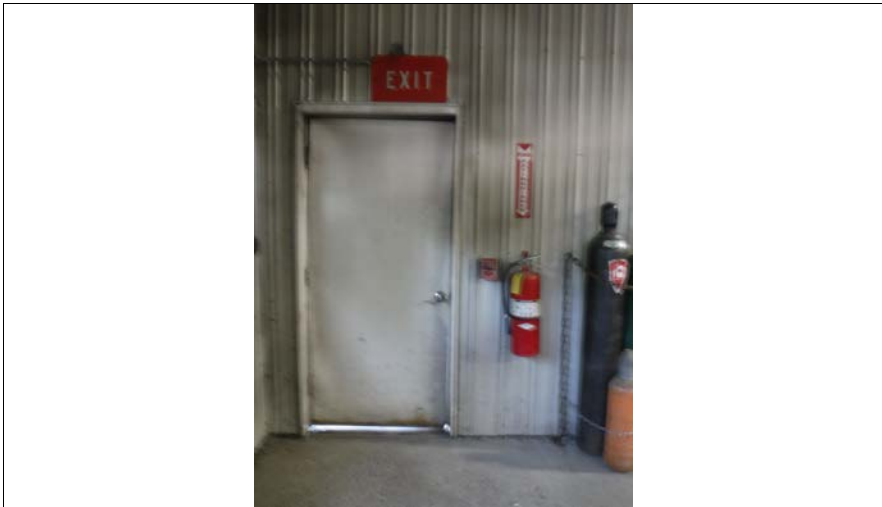
Photo 3

The metal siding is in generally good condition, except for corrosion near the bottom (Photo 4). The wall next to a door in the building can be pushed out several inches with only hand pressure (Sketch Location 5, Photo 3). The soffits have been damaged by insects and no longer function to prevent insects from entering. The pressure treated sill plates that the metal wall siding is fastened to is heavily deteriorated (Photo 4). There is a floor drain in the building, which reputedly has not functioned in many years. The wood framing of the canopy is visibly water damaged, with the ledger showing signs of significant deterioration. Flashing at a building corner is damaged to the point of non-functionality (Sketch Location 6, Photo 8), and flashing around a window appears to be absent (Photo 7). A steel door is significantly corroded and deteriorated (Photo 9), and the glass window in the door is damaged. There is moderate water damage in the plywood roofing.

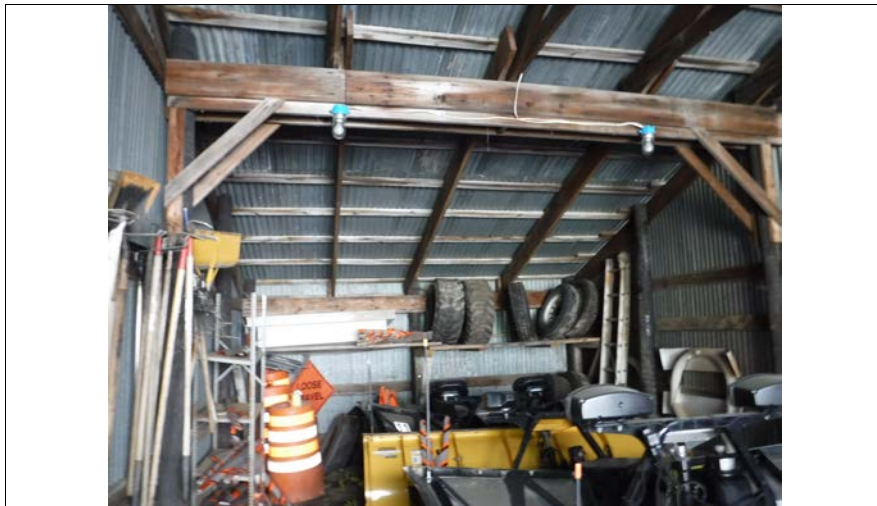
Photo 11

The roof panels appear to be in generally good condition, but show daylight at regular intervals allowing the ingress of water. Moderate water damage is present on the majority of trusses and their supporting framing (Photos 11,12). Several of the poles supporting the structure were observed to be extensively damaged, with one example more than 50% of its section rotted away (Photo 13). Another deteriorated post was observed to be hollow, with around 33% of its section rotted away (Photo 16). A third example has been cut at its base and re-supported on a timber plate (Photo 17), which compromises the

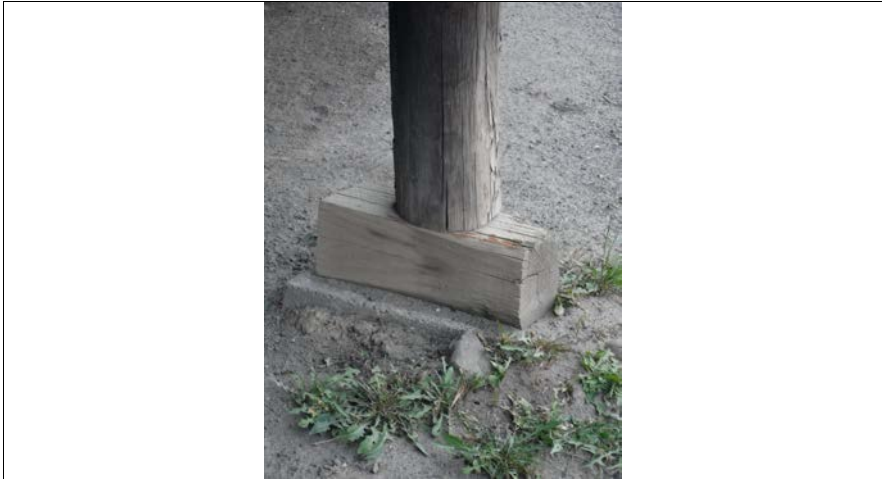
Photo 17

post's ability to transfer lateral loads to the soil. The sill plates along the base of the walls are typically deteriorated, with the sill plate at the rear of the building nearly disintegrated. Also at the rear of the shelter, there is what appears to be an animal burrow, several feet in diameter and deep (Photo 14). The ground surface of the shelter is approximately even with the pavement outside.

3. Replace damaged corner flashing of main building.
4. Replace or otherwise repair rotten timber posts supporting the equipment shelters.
5. Replace strip of corroded wall paneling on exterior of main building near the base of the wall.
6. Provide positive anchorage for the loose wall in main building next to door.
7. Provide sealant or other weather barrier at gap between concrete wall sections in the salt/sand stockpile building.
8. Re-roof shed housing the generator.
9. Replace failed wall sections at the rear of the second equipment shelter.
10. Repair or replace the garage door steel tracks for the salt/sand stockpile building.
11. Replace insect-damaged soffit on main building.
12. Replace roof of main building.

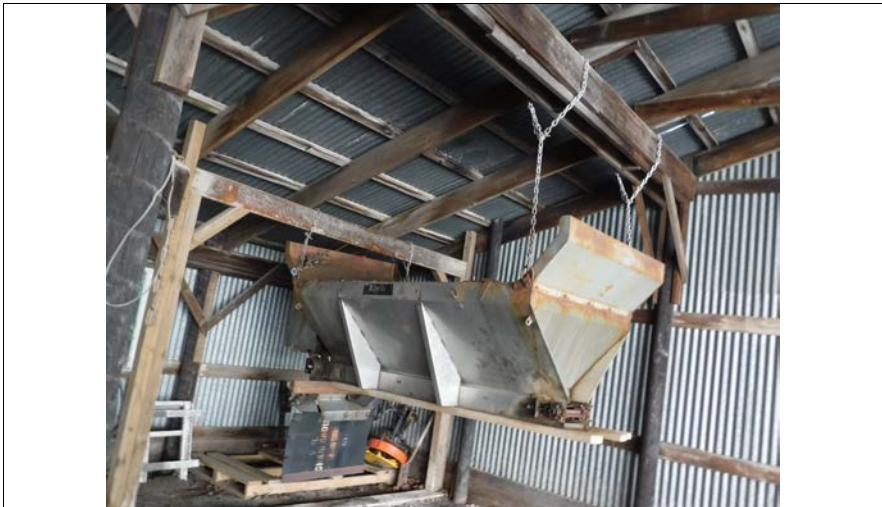
Photo 19

Truck sanders are stored in this shelter when they are not in use. One of the sanders is supported on both a free-standing steel frame, and a roof support beam (Photos 18, 19). This beam is not designed to support the weight of a sander. An additional sander is supported by a roof support beam and a free-standing timber frame. The embedded timber posts in the vicinity of the sanders have a fuzzy surface that is indicative of deterioration due to salt (Photo 20).

1. Provide an alternate support for sanders in equipment shelter instead of hanging from the roof structure.
2. Remove or replace light pole near second equipment shelter.
3. Fill in animal burrow in equipment shelter.

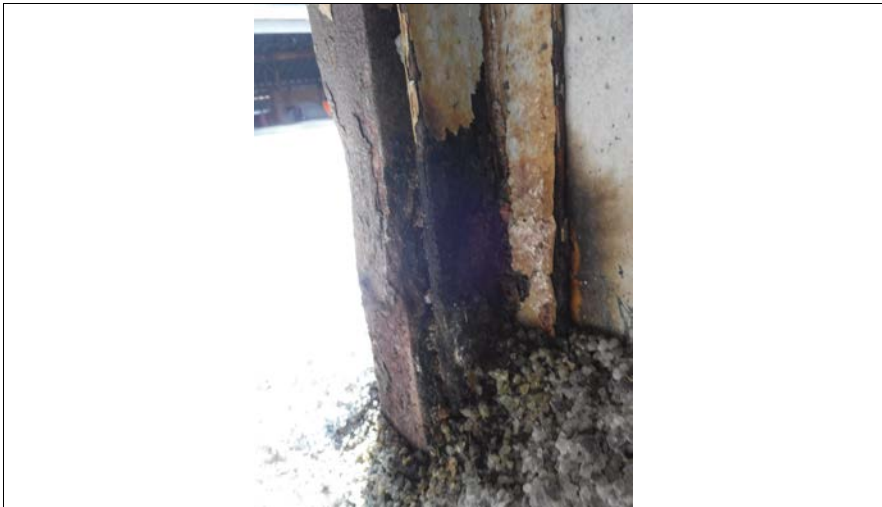
Photo 27

This shelter houses the Department's stockpile of salt/sand mixture before it is loaded into sanders and applied to town roads. The structure is a cast-in place concrete building with metal roof panels applied to purlins spanning between timber trusses that are supported by the concrete walls. Steel tie-rods connect the tops of the two longer concrete walls. There is separation of several inches between sections of concrete wall along the northwest wall of the building. Mild deterioration of the concrete walls is evident, due to the high chloride environment and impacts from equipment. There is an overhead garage door on one wall that is no longer operable due to damaged and severely corroded tracks (Photos 26, 27).

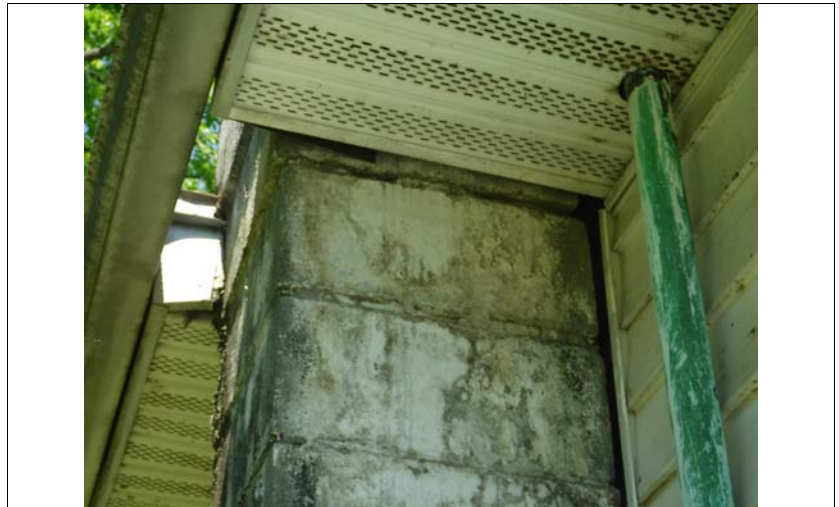
Photo 4

Sections of the siding and soffit are missing or not properly attached on the southwest wall (Photos 6, 7, 11). A concrete masonry chimney is leaning away from the building compromising the weather barrier of the building (Photo 4).

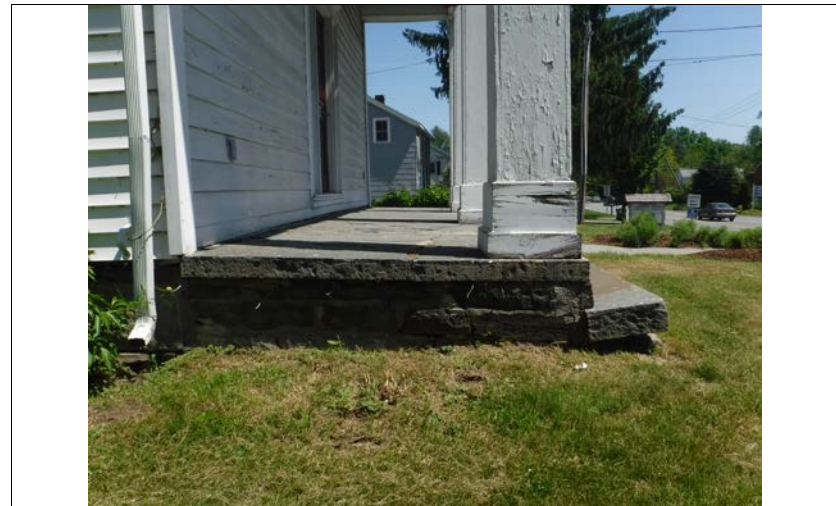
Photo 8

Wood trim boards around columns at the front of the historic building are rotting (Photo 8). The condition of the columns themselves were not observable due to the trim covering them.

A step leading up from the front yard to the building's front door is settled and rotated. Stone masonry has been laid atop most of this step to provide a level surface (Photo 8). A step in the stairway leading from the Main Street sidewalk to the front yard is also settled and rotated, resulting in a significant trip hazard (Photo 9). The stair riser height of the step at the rear entrance is 9½", which exceeds the maximum height allowable by the building code (Photo 18).

1. Grade the side lot on the southwest to divert runoff to a ditch at the base of the adjacent property and away from the building wall.
2. Grade the pavement on the northwest side of the building to divert runoff away from the building.
3. Grade the strip of soil on the northeast side of the building to drain water away from the building.
4. Paint the exterior wood components of the building.
5. Replace rotten wooden components on the building's exterior, especially the trim around the columns at the front of the building. The condition of the columns should be evaluated when the trim boards are removed and the columns replaced if rot is present.

1. Re-set tilted front step and re-lay settled flagstone near staircase.
2. Replace or reconfigure step at rear entrance to meet current code requirements.
3. Re-roof building & at the same time address sagging rooflines.

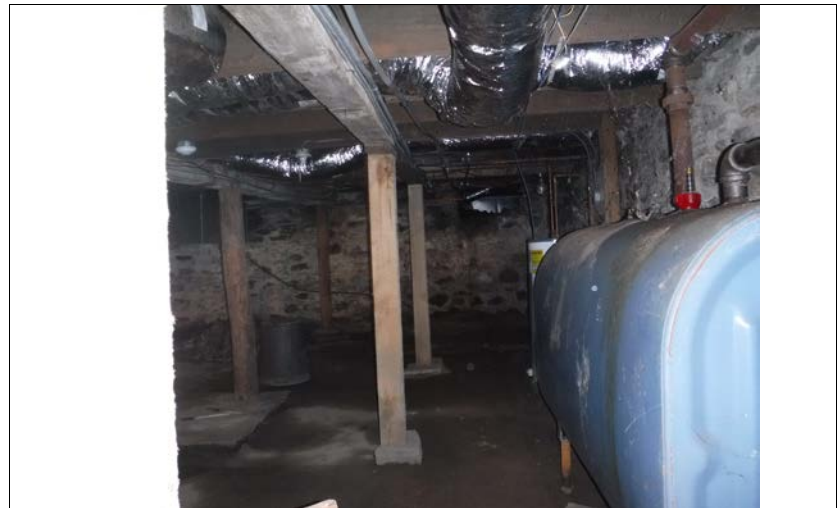
Photo 20

A concrete masonry wall in the newer basement has been retrofitted with a dimensional lumber stud wall anchored to the slab and to the floor system above (Photo 14). Excessive moisture was observed in this area of the basement. A dehumidifier was present, but it had shut off when it became full of water and was in need of emptying. Several wood posts in this area are supported on the slab, and the post ends were saturated from being in contact with the wet slab (Photo 15). The basement wall opposite the masonry wall is poured concrete and shows a high level of separation due to insufficient vibration to settle the concrete during the pouring process (Photo 16). This is not a structural concern. The historic section of basement also has excessive moisture in and on the floor (Photo 20).

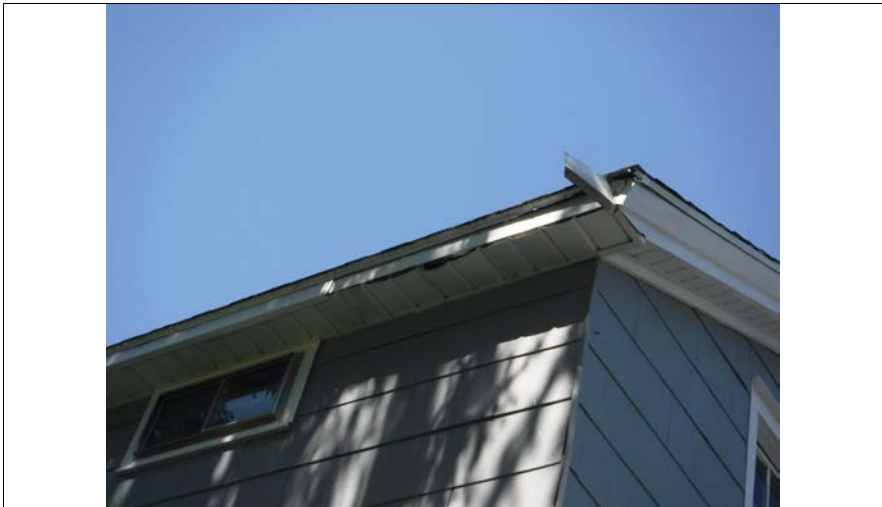
Photo 3

There are holes in the roof fascia and soffit that allow pests into the second floor (Photo 3). Water damage was observed on the gable end wall near the chimney. An opening in the second-floor wall has been covered with what appears to be plywood siding panels (Photo 7). Similarly, the rear door to the annex building is a barn-style sliding door (Photo 7). Neither of these coverings creates a weather barrier, nor prevent pests from accessing the building. The areas around the sill plate show areas of significant rot and damage, allowing ingress of water and rodents (Photo 8).

1. Repair damaged roof fascia and soffit.
2. Remove vegetation growing in or on the building.

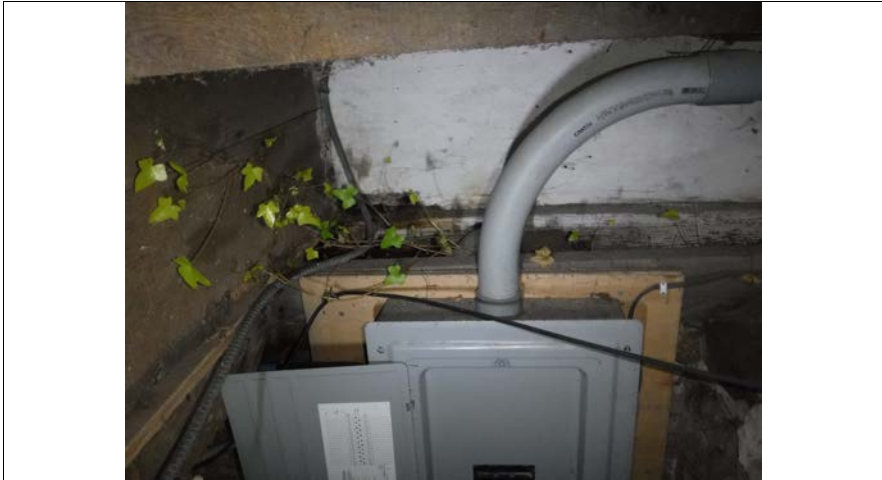
Photo 5

Vegetation is growing in the stairwell near the electrical panel (Photo 5). Windows are single-pane, and several windows are broken. Penetrations into the foundation, made to allow electrical cables to pass to the vehicle charging station, allow ingress for rodents (Photo 9).
