Catskill Aqueduct: Rondout Pressure Tunnel Town of Marbletown Board Update

November 15, 2022

History of Rondout Pressure Tunnel

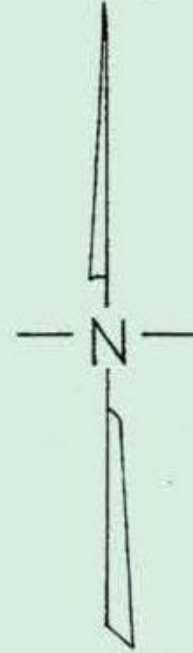
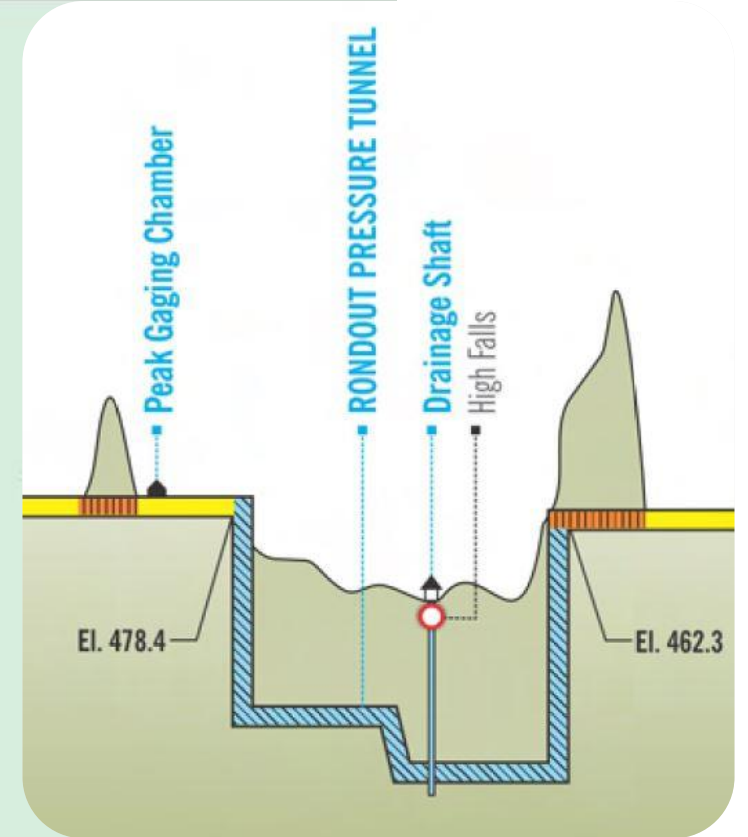
Rondout Pressure Tunnel

At its lowest point:

250 ft below sea level
493 ft below ground

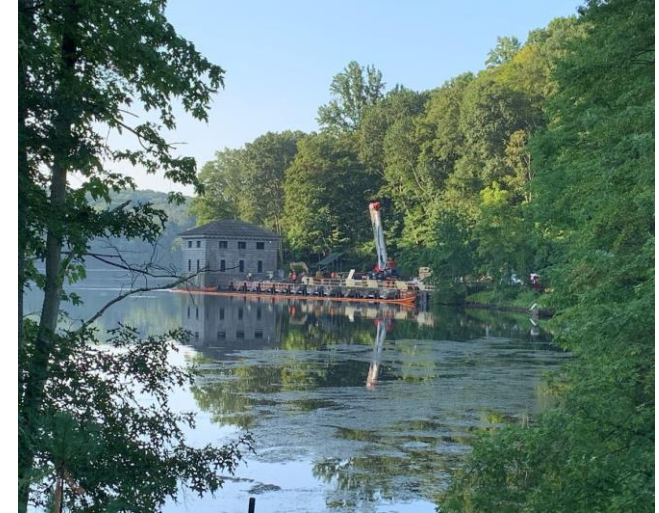
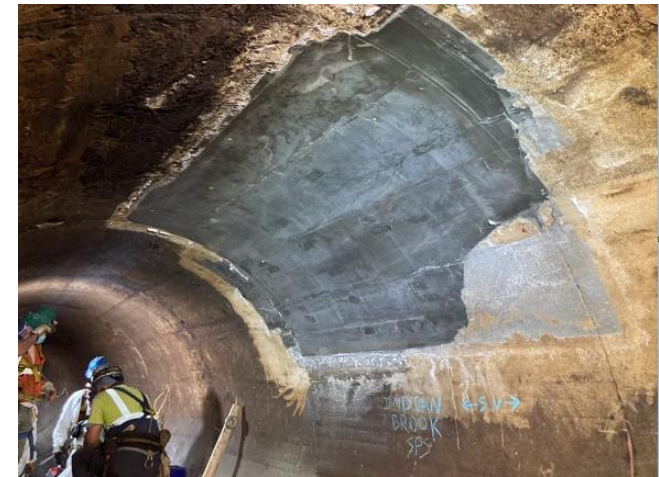
- Fall 2018 – 56 Days (October 2018 – January 2019)
 - Inspections, internal crack repair, ladder removal, biofilm removal pilot test.
- Fall 2019 – 74 days (November 2019 – January 2020)
 - Culvert drain sluice gate closure/replacement, biofilm removal, abandoned community tap removal, defect repairs.
- Spring 2020 - 20 days (April 2020)
 - Poor Farm Arch structural repairs.
- Fall 2020 – 75 Days (November 2020 – February 2021)
 - Valve leak repairs at Rondout and Wallkill Pressure Tunnel drainage chambers.
- Fall 2021 - 73 days (10/2/21 to 12/14/21)
 - Biofilm removal at steel pipe siphons.
 - Catskill Influent Wier repairs and flashboard installation.
 - Siphon valve replacement.
 - Reinforced concrete cap at select aqueduct locations, EOR inspection and repair.
 - Carbon fiber reinforced polymer wall and invert repairs at select locations.
 - Defect repairs at steel pipe siphons.

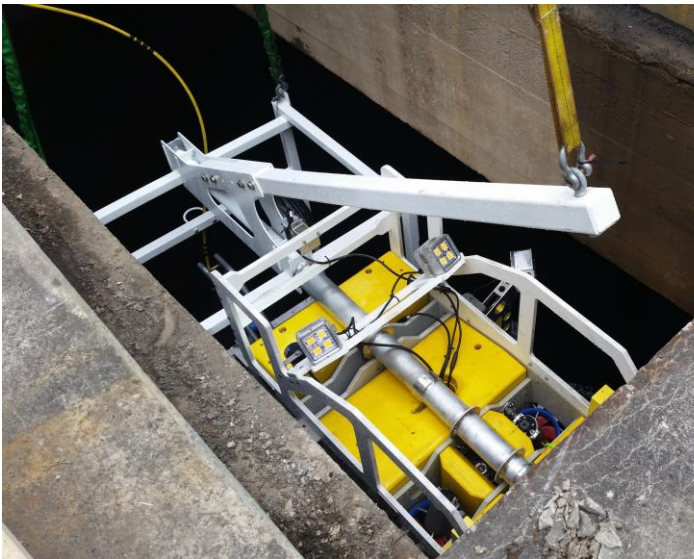
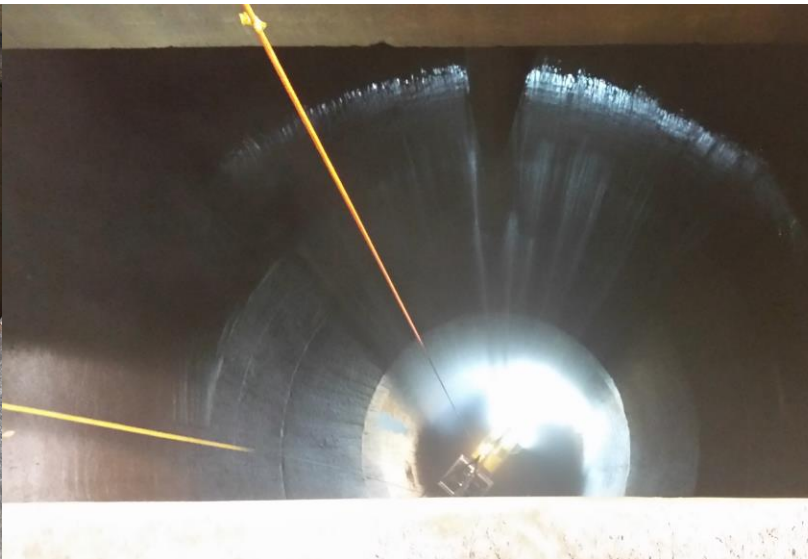
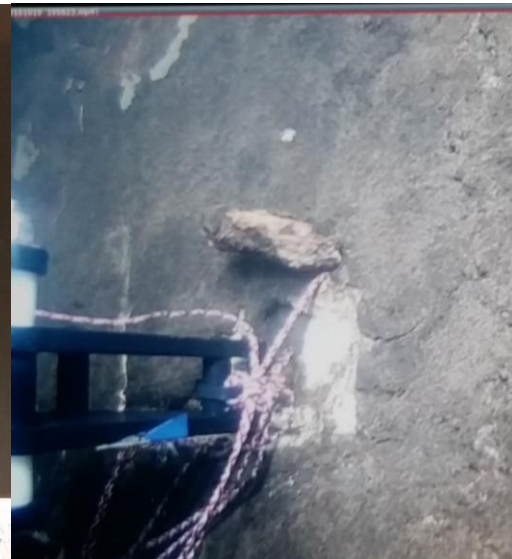
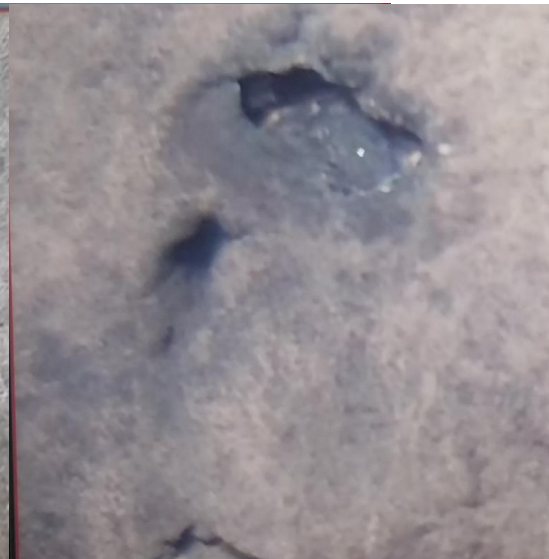
Rondout Pressure Tunnel ROV

- October 2016 – Remote Operated Vehicle (ROV) inspection.
 - Acoustic surveys to identify locations of suspect tunnel defects.
 - Targeted, detailed inspection of suspect defect locations using dye tests, cameras, hydrophone and tell tails.
 - Identified 11 confirmed leak locations; liner cracks and two small debris piles
- December 2022 – Next ROV inspection planned under CAPT project to assess current tunnel conditions and compare to the 2016 inspection results.
