# MARBLETOWN LANDMARK DESIGNATION APPLICATION

historic name Henry Brodhead House

street & number 550 North Marbletown Road SBL: 62.1-3-11. ☐ not for publication

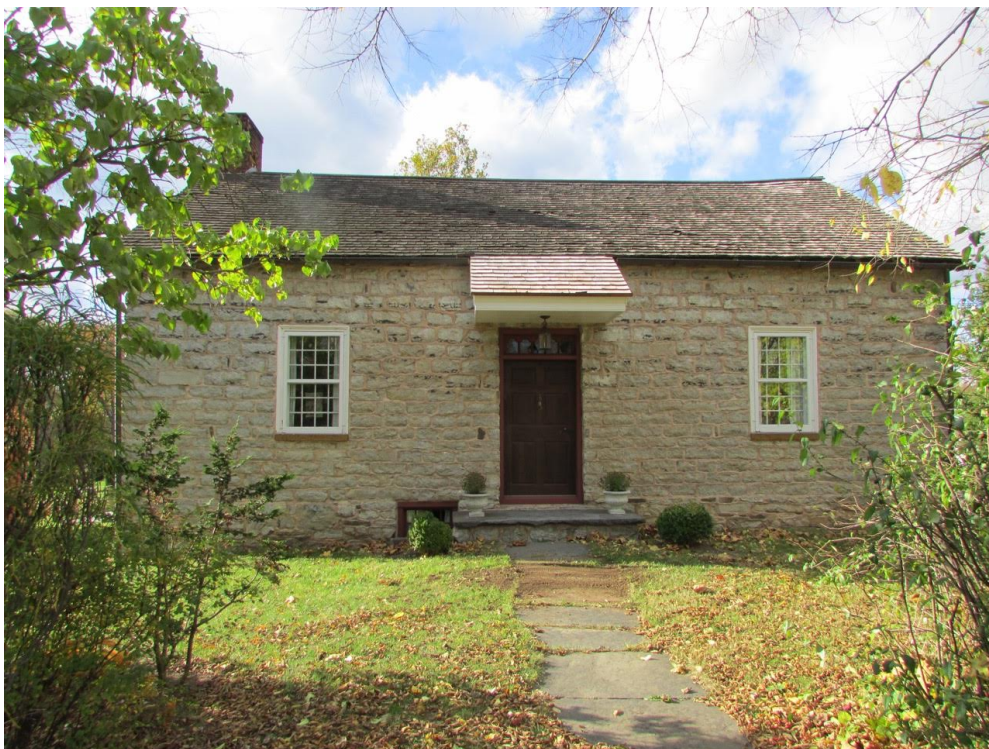
**Above: Front of the Henry Brodhead House, looking west.**

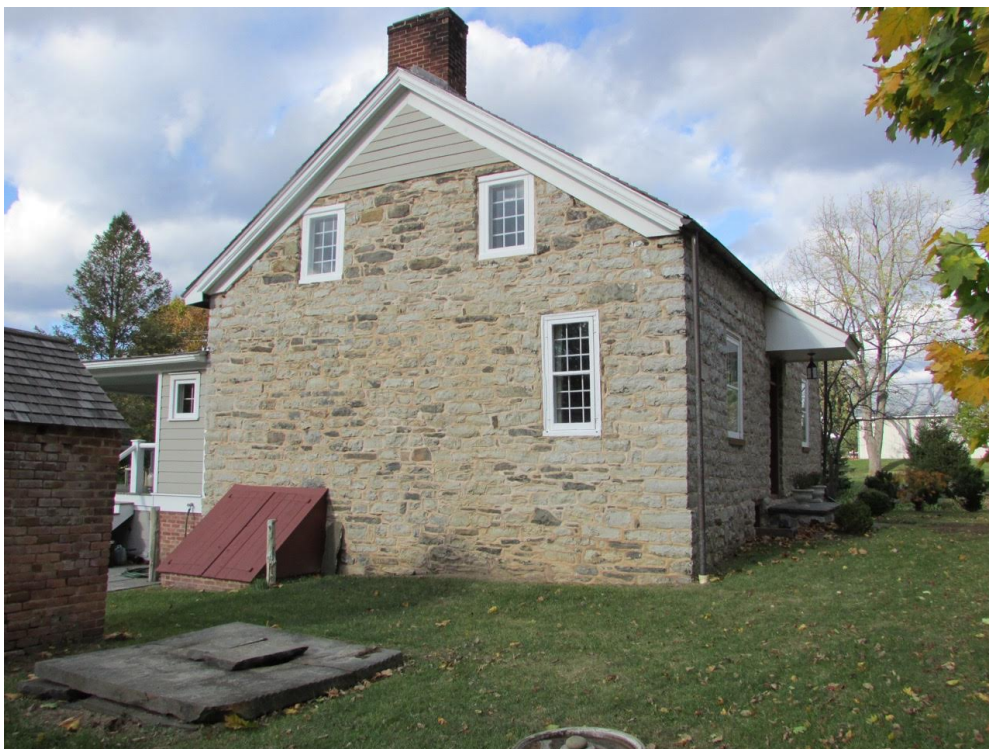
**Below: South gable end of the house with a bit of the porch, cellar entrance, smokehouse, and well.**

The outside cellar entrance was moved from the front of the house to the south gable end, very likely to protect the cellar from water seepage caused by the natural slope of the land and the proximity of the road. A door was also cut in the stone wall between the cellar and the enclosed space underneath the new kitchen. There are two cisterns that seem to have been built at different times. The entrance from the cellar would have been a means of accessing the smaller of the two (a hand pump would have brought water from it up to the kitchen). The best theory now is that the second, larger cistern was built during this period. A number of now-outdated documents refer to the Henry Brodhead House as the “De Witt tenant house,” and in fact ceiling “shadows,” damage to original elements, and repairs suggest that the house was divided up for renters during the De Witt ownership – the point being that a larger cistern may have been needed to meet the tenants’ needs.

The smokehouse by the south gable wall is made of nineteenth-century bricks in English bond, suggesting it was built during Phase Three. It has a dirt floor and measures 75.0” wide by 83.0” long by 112.0” high at the peak of the gable-end brickwork (81.0” at the roof footing along both sides). The door frame is 32.5” x 68”. The eighteenth-century two-panel tongue-in-groove batten door is from an older structure, possibly the lean-to addition removed when the existing kitchen extension was built. The door has rose-head nails and early ironwork, including pintles and foot-long straps, one with a heart-shaped nailing pad and the other with a plain pad.

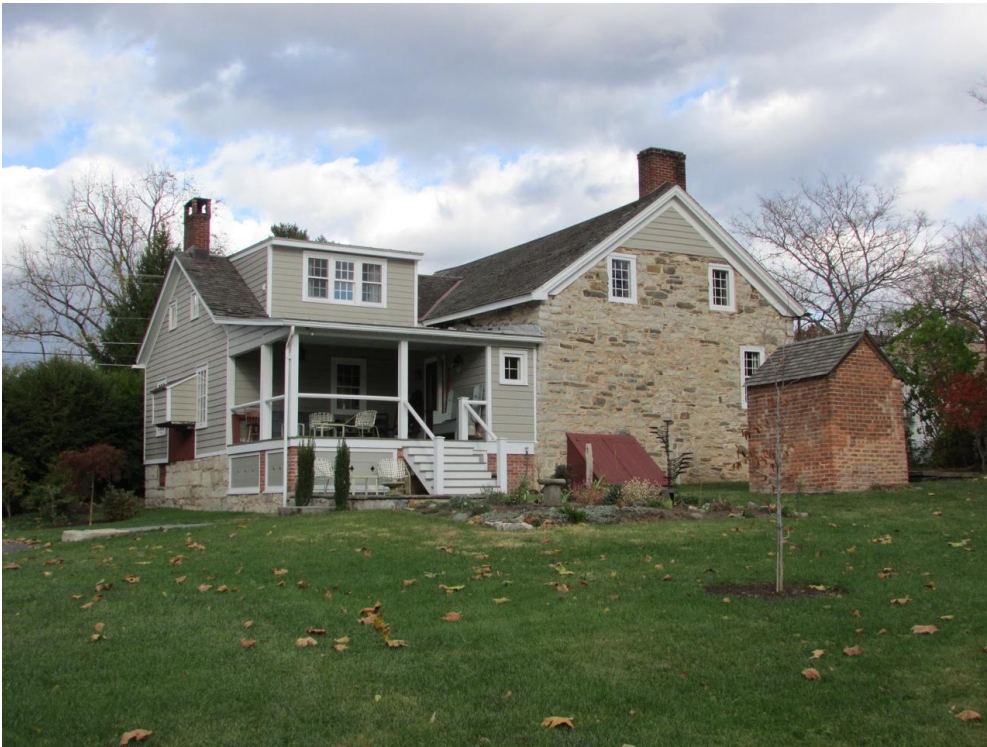
**Above: South end of the house with porch and bathroom dormer. Note beehive oven on the rear wall of the kitchen addition.**

The 1991 bathroom was extended the length and width of the attic space over the kitchen, making room for three windows, a large sink, a shower and separate bathtub, an alcove for washer and dryer, and a storage area that holds a forced-air heating and air-conditioning unit. Ducts and outlets for the heat and air-conditioning are located in the floor and ceiling of the bathroom for minimum visibility, and in the dead space above the small wood room in the garret, where they are essentially invisible. Finally, two small windows were added to either side of the chimney in the west-facing gable end of the bathroom.

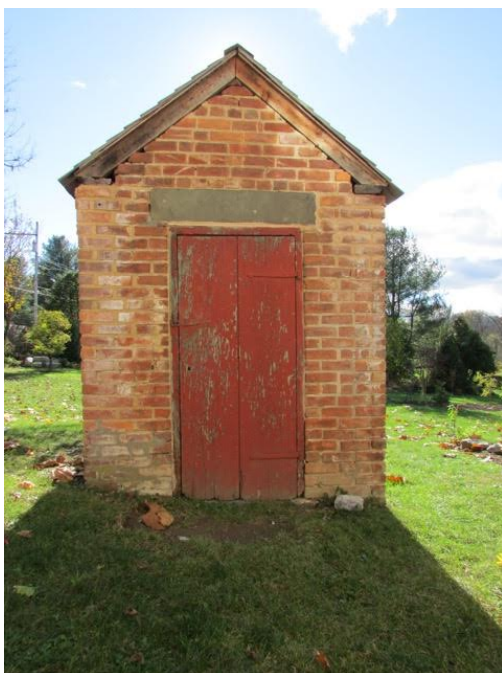
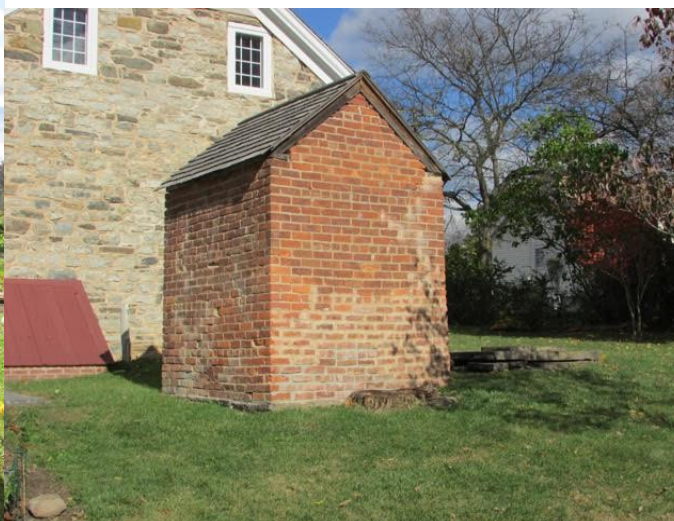
**Below: Front of smokehouse looking south and back looking northeast.**

This left the brick smokehouse and the dug well adjacent to it as the only reminders of the Burnt Orchard's agricultural past. The well has been covered with a thick bluestone slab for many years, protecting the stone walls from damage. As found in 2010 the smokehouse was also in good condition except for gaps above the bluestone sills on three sides of the building, created when rotten brickwork collapsed. These gaps were repaired with early twentieth-century bricks from nearby Kingston, NY, pointed with color-matched lime mortar. The same pointing has been used to repair the outside walls where needed. The inside retains what appear to be the original soot-blackened rafters. The dirt floor yielded the bones of cattle, deer, and turkeys as well as muskrat claws and the tusked jawbones of feral hogs. The roof was rebuilt with old timber and cedar shakes.

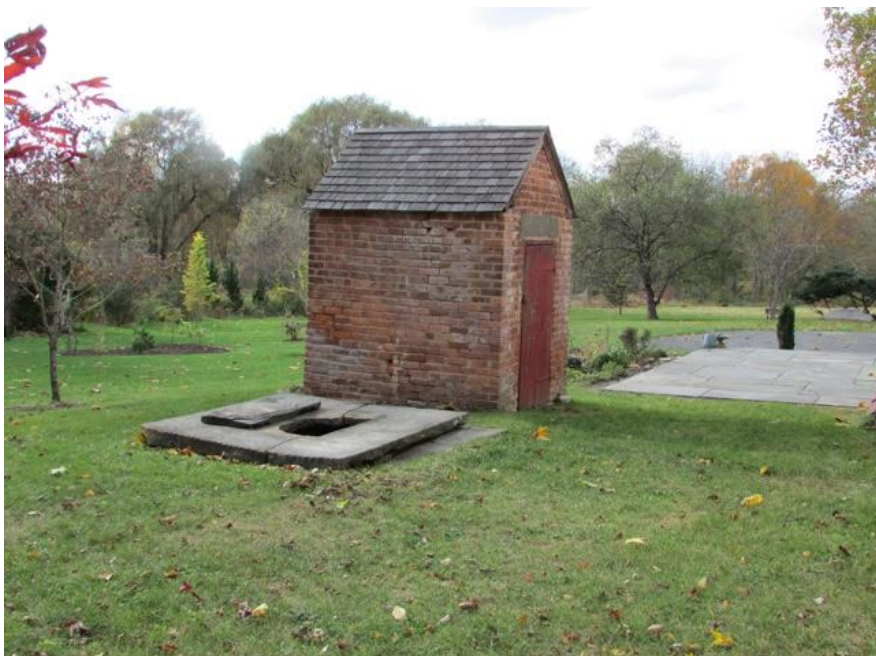
Above: Smokehouse and porch patio, looking west.

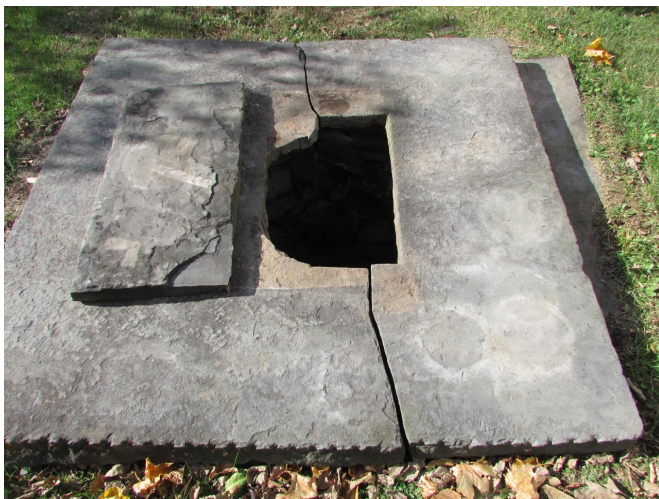
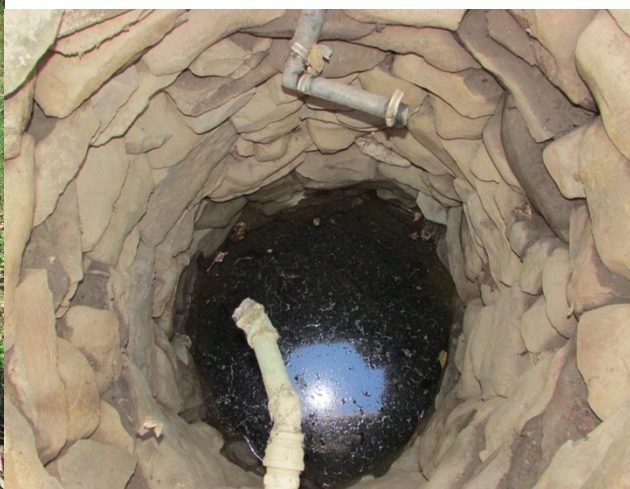
Below: Well with bluestone cover and inside stonework (pipes no longer functional).
