# EVALUATION OF TOWN-OWNED PROPERTIES TOWN OF MARBLETOWN, NY

PREPARED FOR:  
Town of Marbletown  
1925 Lucas Ave.  
Cottkill, NY 12419

Peak Engineering, PLLC  
3751 Main Street – PO Box 540  
Stone Ridge, NY 12484

July 9, 2019

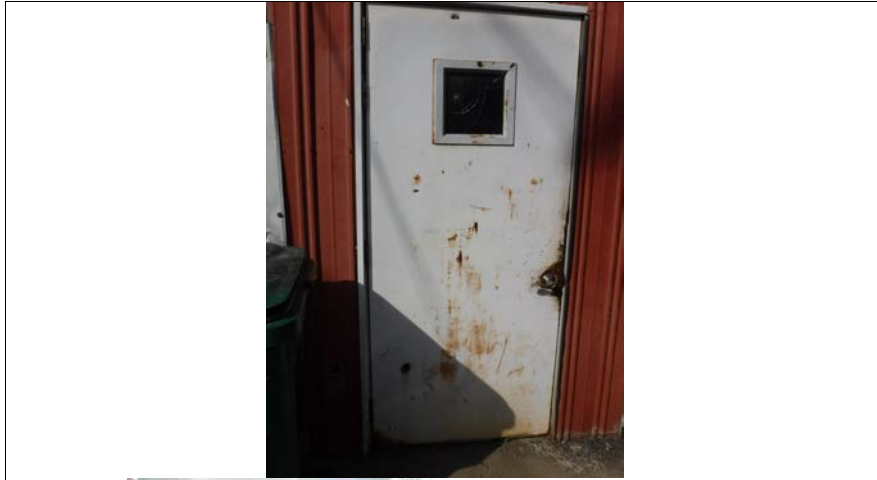
Photo 9

The metal siding is in generally good condition, except for corrosion near the bottom (Photo 4). The wall next to a door in the building can be pushed out several inches with only hand pressure (Sketch Location 5, Photo 3). The soffits have been damaged by insects and no longer function to prevent insects from entering. The pressure treated sill plates that the metal wall siding is fastened to is heavily deteriorated (Photo 4). There is a floor drain in the building, which reputedly has not functioned in many years. The wood framing of the canopy is visibly water damaged, with the ledger showing signs of significant deterioration. Flashing at a building corner is damaged to the point of non-functionality (Sketch Location 6, Photo 8), and flashing around a window appears to be absent (Photo 7). A steel door is significantly corroded and deteriorated (Photo 9), and the glass window in the door is damaged. There is moderate water damage in the plywood roofing.

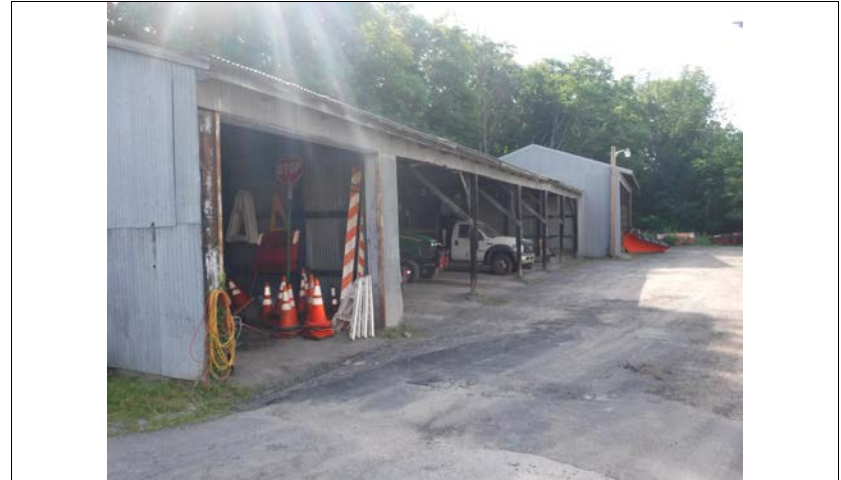
Photo 10

The first of the equipment shelters is a timber pole-type structure with a mix of corrugated metal and plastic panels for roofing fastened to wood purlins, supported by trusses (Photos 10,11,12). The walls are covered with corrugated metal panels fastened to wall girts supported by the vertical poles that are driven into the soil. There is electric service in this building, which houses tractors, plows, and other miscellaneous equipment used by the Department.

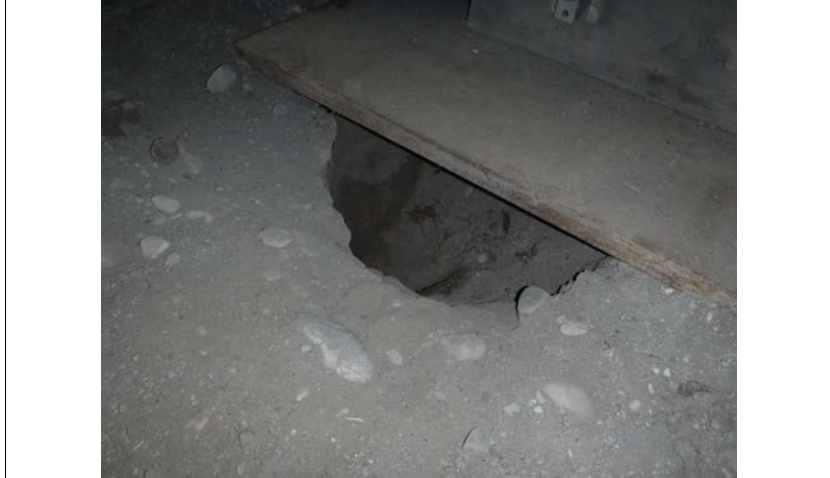
Photo 14

post's ability to transfer lateral loads to the soil. The sill plates along the base of the walls are typically deteriorated, with the sill plate at the rear of the building nearly disintegrated. Also at the rear of the shelter, there is what appears to be an animal burrow, several feet in diameter and deep (Photo 14). The ground surface of the shelter is approximately even with the pavement outside.

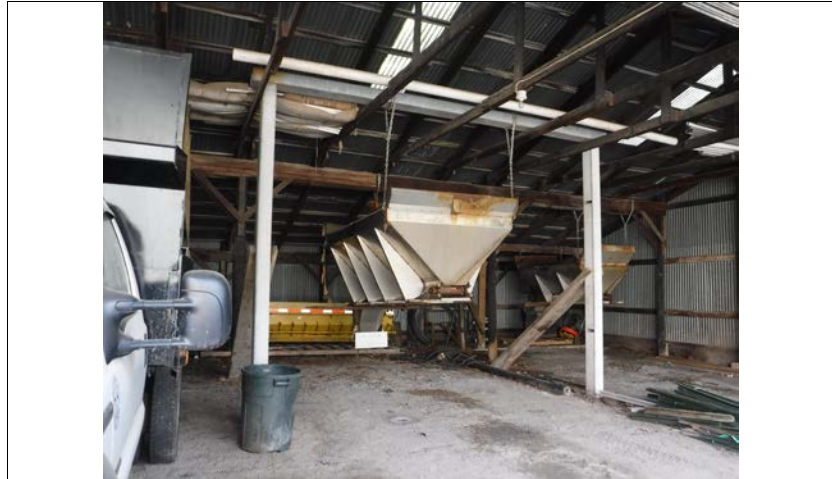
Photo 18

Truck sanders are stored in this shelter when they are not in use. One of the sanders is supported on both a free-standing steel frame, and a roof support beam (Photos 18, 19). This beam is not designed to support the weight of a sander. An additional sander is supported by a roof support beam and a free-standing timber frame. The embedded timber posts in the vicinity of the sanders have a fuzzy surface that is indicative of deterioration due to salt (Photo 20).

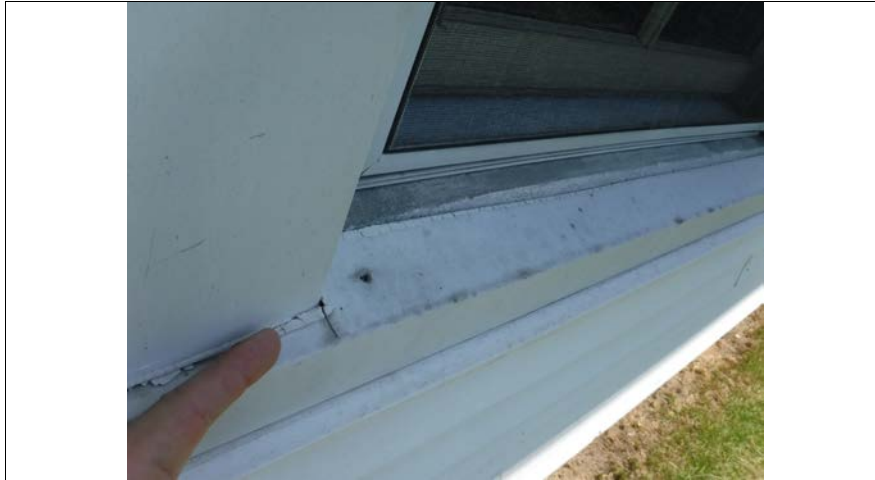
Photo 5

The paint coatings over many of the exterior windows and on portions of the siding are failing. Several sections of flashing around windows was observed to be improperly implemented, allowing water ingress (Photo 5). The majority of gutter downspouts were observed to be obstructed by vegetation or soil, and some downspouts were disconnected (Photo 10).

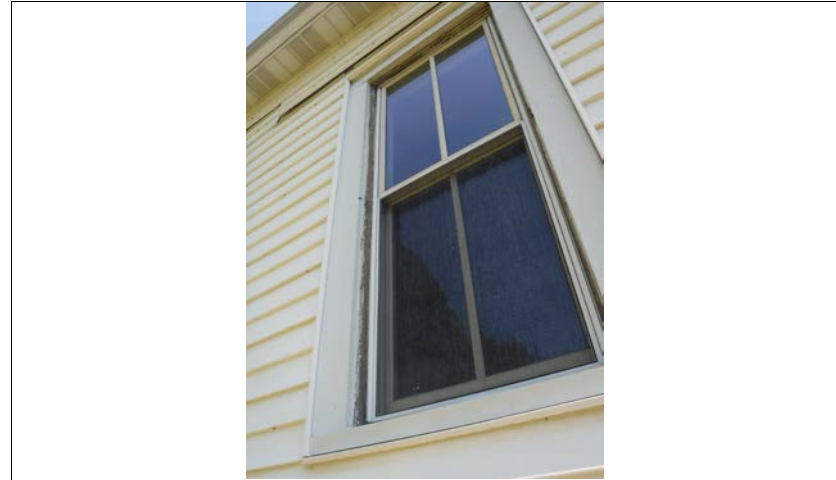
Photo 6

Sections of the siding and soffit are missing or not properly attached on the southwest wall (Photos 6, 7, 11). A concrete masonry chimney is leaning away from the building compromising the weather barrier of the building (Photo 4).

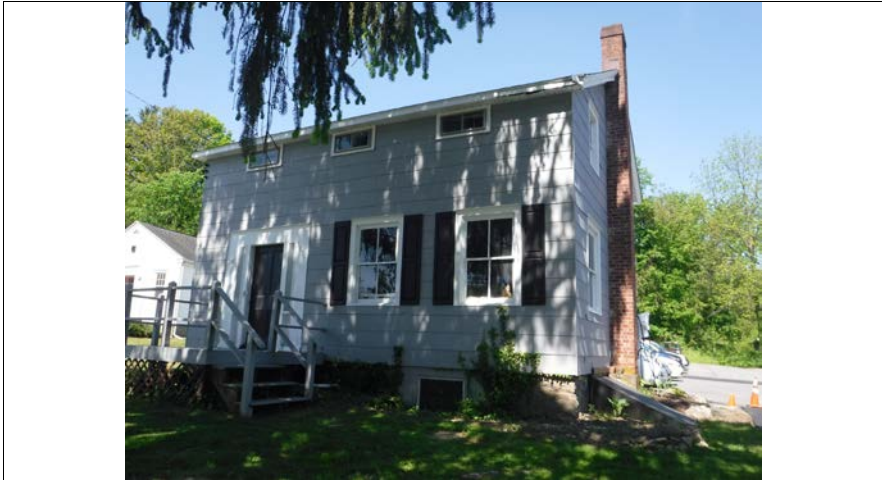
Photo 1

The Annex building is a 26'x20' two-story wood-frame building with a full basement (Photo 1). Overall the condition of the structure is poor. The roof ridge is sagging when viewed from the exterior, and the tops of the second-floor walls appear to splay outward. Asphalt roof shingles are applied to plywood over skip sheathing spanning between timber rafters. The older timber rafters are reinforced with modern dimensional lumber (Photo 2), and dimensional lumber ceiling ties are provided every 4 rafter bays. Perimeter walls are full dimension 2x4 stud walls running between floors and from the second floor to the roof. The original second floor framing is full-sawn joists spanning between exterior walls, augmented by a retrofit wood beam with steel flitch plates at the second floor midspan (Photo 4). The first-floor framing is identical to the second-floor framing, with the exception that the retrofit central beam is not reinforced with steel flitch plates, but is supported by multiple posts along its length (Photo 12). The first-floor joists show significant moisture and deterioration (Photo 6). There is a wooden deck on the front of the building supported on concrete piers (Photo 10).

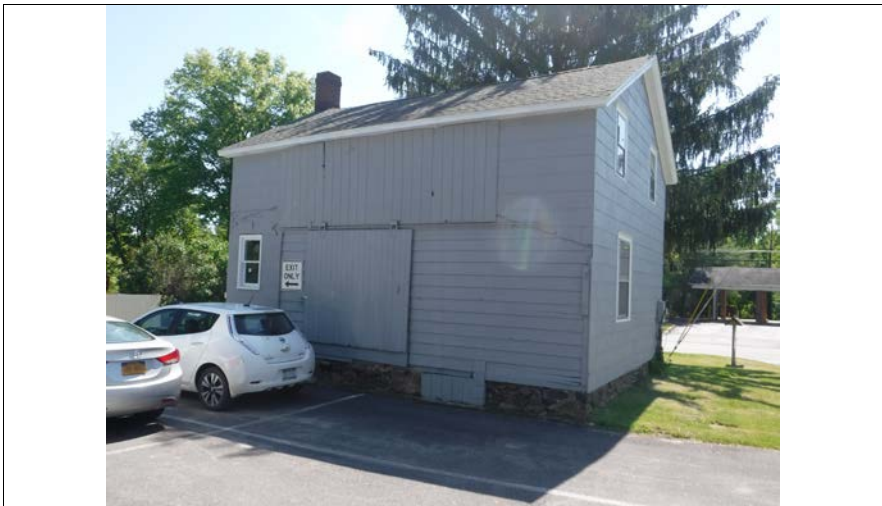
Photo 7

There are holes in the roof fascia and soffit that allow pests into the second floor (Photo 3). Water damage was observed on the gable end wall near the chimney. An opening in the second-floor wall has been covered with what appears to be plywood siding panels (Photo 7). Similarly, the rear door to the annex building is a barn-style sliding door (Photo 7). Neither of these coverings creates a weather barrier, nor prevent pests from accessing the building. The areas around the sill plate show areas of significant rot and damage, allowing ingress of water and rodents (Photo 8).

Based on visual observations, the roof shingles appear to be in fair condition, but the rest of the weather barrier is in degraded condition due to damage or material deterioration. Of special concern are the plywood siding panels covering the second story opening. The top of this covering is pulled away from the building.

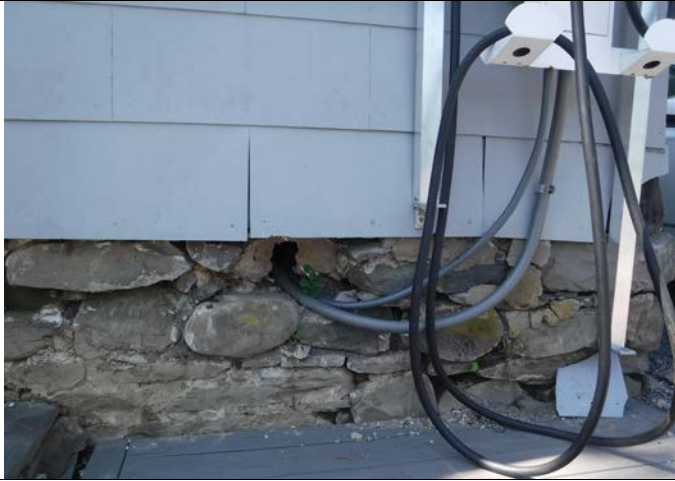
Photo 9

Vegetation is growing in the stairwell near the electrical panel (Photo 5). Windows are single-pane, and several windows are broken. Penetrations into the foundation, made to allow electrical cables to pass to the vehicle charging station, allow ingress for rodents (Photo 9).

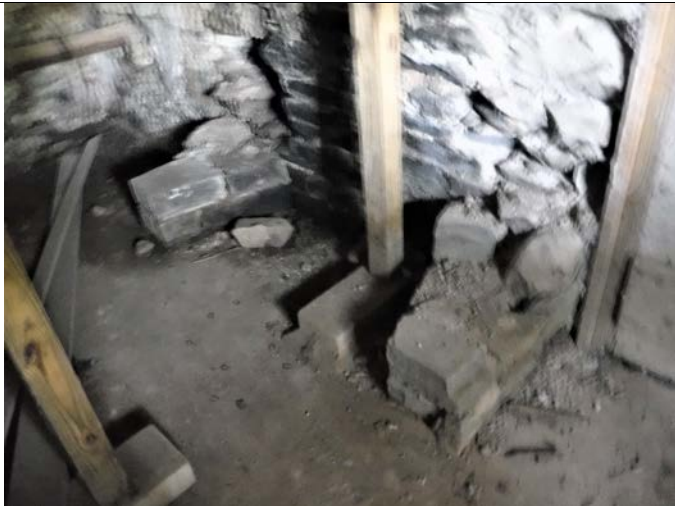
Photo 11

The basement walls are mortared stone masonry with heavily deteriorated mortar (Photo 11). Footings below the basement walls were not observable beyond the concrete basement slab. Posts from the first-floor beam down to the concrete slab are supported by concrete pads placed atop the slab.

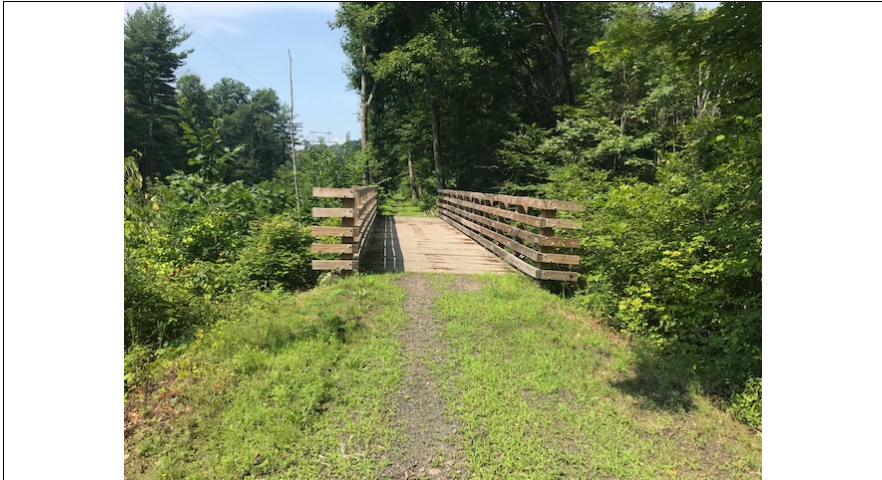
Photo 1

Bridge #8 is located approximately ½ mile north of Williams Lumber & Home Center (see Bridge #8 photos). Construction is steel girders with a timber deck and railing. The steel beams used for the structure were refurbished and installed in 2013 on a concrete pedestal atop existing laid-up stone abutments. This bridge spans 48'-9" over Kripplebush Creek. The condition of this bridge is good and we have no recommended repairs or maintenance at this time.
